**Subject: Geotechnical Study
Proposed DAX9 Warehouse Improvements
1211 Badillo Street
West Covina, California**

**GEOTECHNICAL STUDY
PROPOSED DAX9 WAREHOUSE IMPROVEMENTS
1211 BADILLO STREET
WEST COVINA, CALIFORNIA**

KLEINFELDER PROJECT NO. 20203313.001A

NOVEMBER 13, 2020

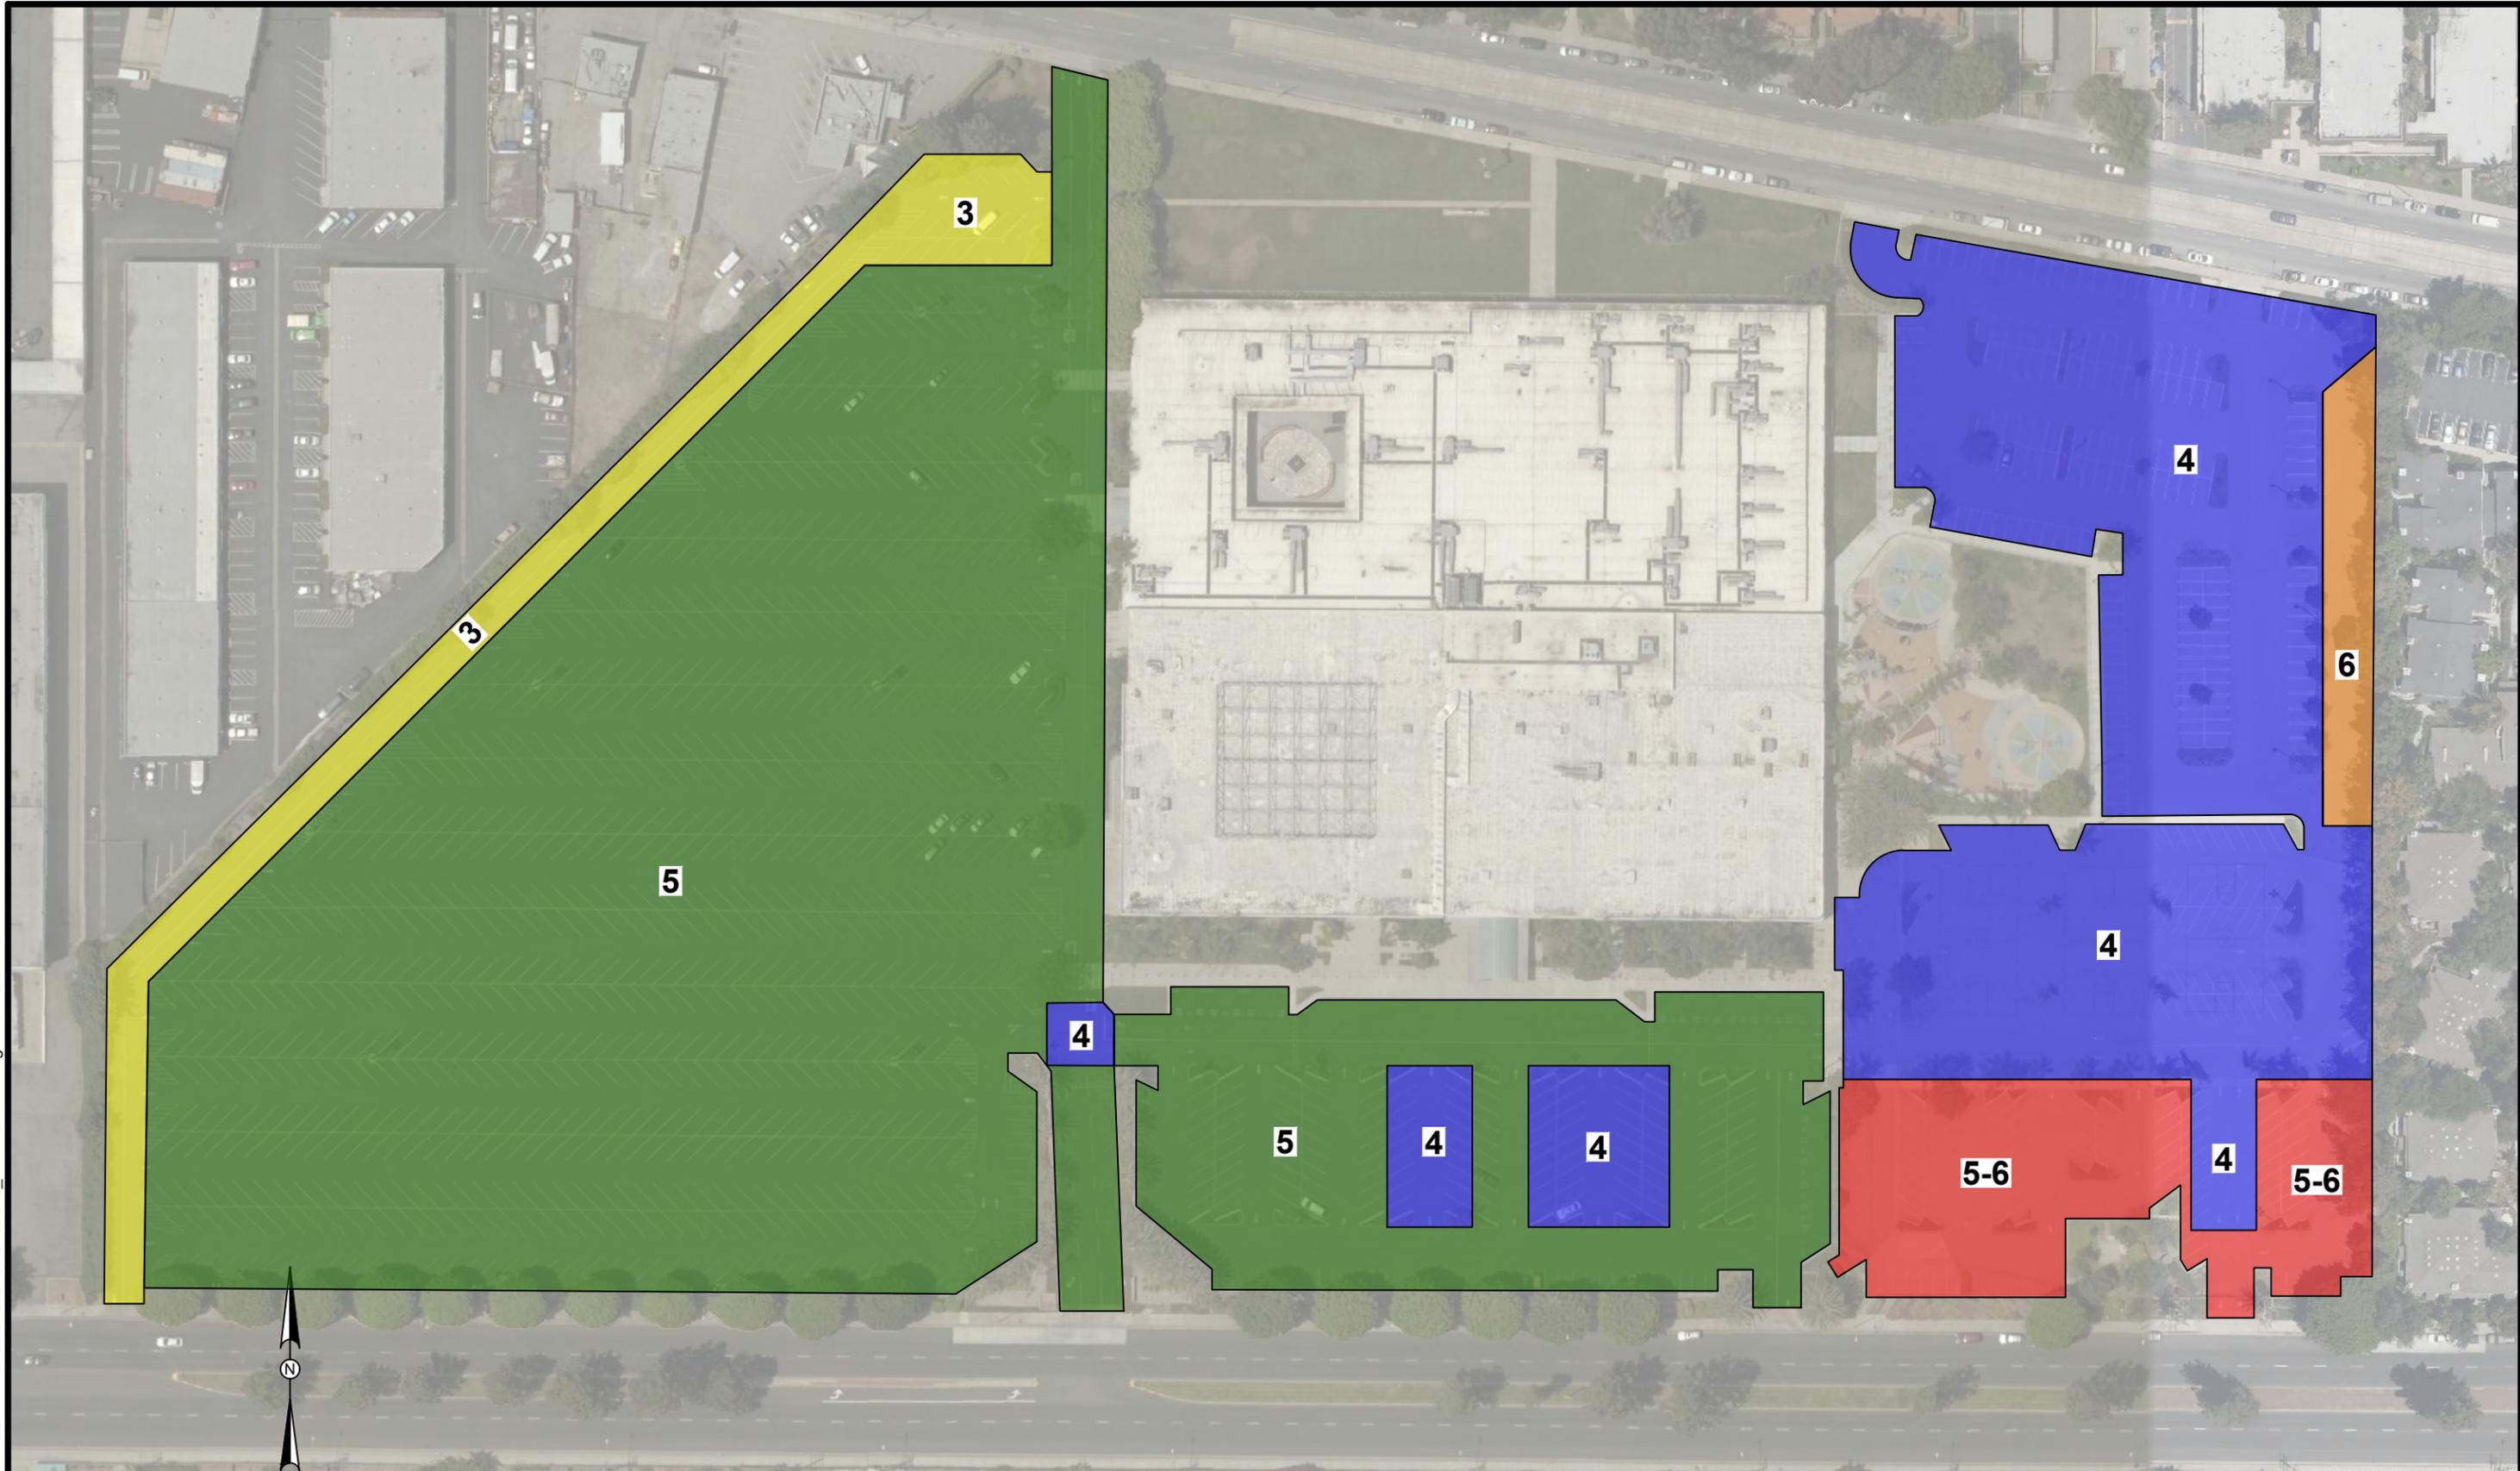
FIGURE
 3

The asphalt concrete (AC) pavement condition varies across the site with some isolated areas that are in failed condition (PASER rating of 3) near the western boundary of the site. The majority of the AC pavement is in fair condition with a PASER rating of 4 or 5. In a few areas the pavement is in good condition with a PASER rating of 5 to 6, such as the eastern boundary of the site and the parking area in the southeast corner. Figure 3 shows pavement conditions and PASER ratings.

In AC areas with PASER ratings of 3, pavement distress generally consisted of alligator cracking, isolated potholes, and loss of surface integrity. In AC areas with PASER ratings of 4 or 5, the pavement distress generally consisted of widespread longitudinal and transverse cracks with widths greater than ½ inch and block cracking over more than 50 percent of the surface. In a few areas with a PASER rating of 5 to 6, the pavement distress consisted of longitudinal and transverse cracking that was less prevalent.
