PHASE I ENVIRONMENTAL SITE ASSESSMENT REPORT

FORMER MAZDA CAR DEALERSHIP
2539 East Garvey Avenue
West Covina, California 91791

May 16, 2013
Partner Project No. 13-102449.5

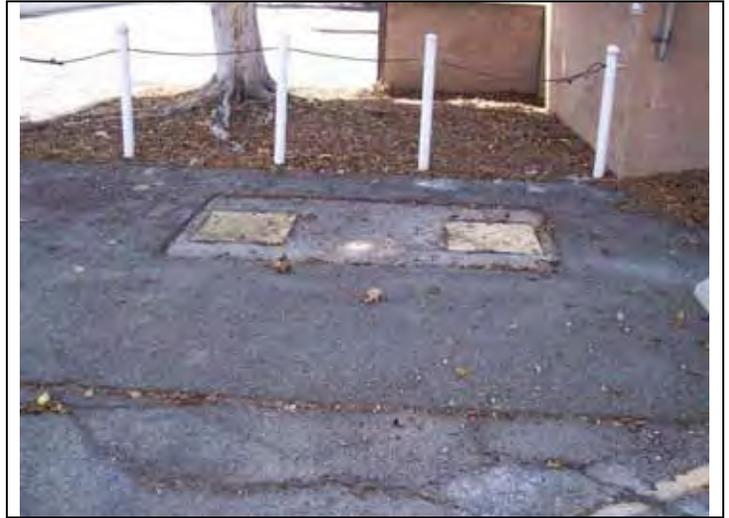
- A two-chambered clarifier was observed to the central-western portion of the subject property within the asphalt-paved parking area. A drain system located within the service bay area is associated with the clarifier. Clarifiers are used to treat waste water streams. Partner only observed drains in the wash bay area of these buildings, along with three surface drains outside the buildings within various locations on the subject property. No staining was observed on and around the wastewater clarifier. According to building permits, the car dealership was built in 1967 and it is likely that the clarifier was built during that time and used to filter wastewater from the concrete washout area utilized during automotive service operations. Based on the nature of operations associated with the car dealership, there is the potential that wastewater generated by the subject property was impacted with residual oils and/or solvents used in service operations. Hazardous materials present in the waste stream could impact the soil beneath the property if the clarifier or drain system was compromised. The clarifier and drain system on the subject property represent a recognized environmental condition for the subject property.

13. View of the clarifier location on the central-western portion of the subject property looking west.

14. View of the clarifier location on the central-western portion of the subject property looking west.

- Partner recommends conducting a subsurface investigation in the area of the wastewater clarifier and drain system, and near the former in-ground hydraulic vehicle lifts in order to determine the presence or absence of soil and/or groundwater contamination.
- An Operations and Maintenance (O&M) Program should be implemented in order to safely manage the suspect ACMs located at the subject property.

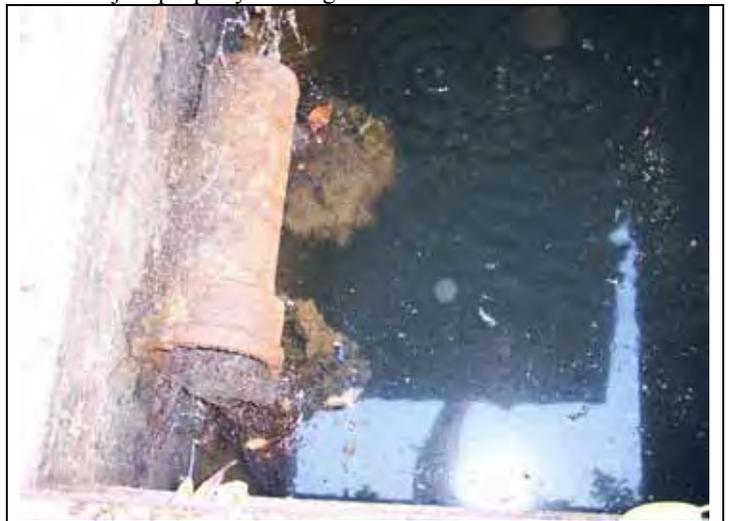
15. View of the clarifier location on the central-western portion of the subject property looking north.

16. View the interior of the clarifier chamber filled with water and oil sludge.

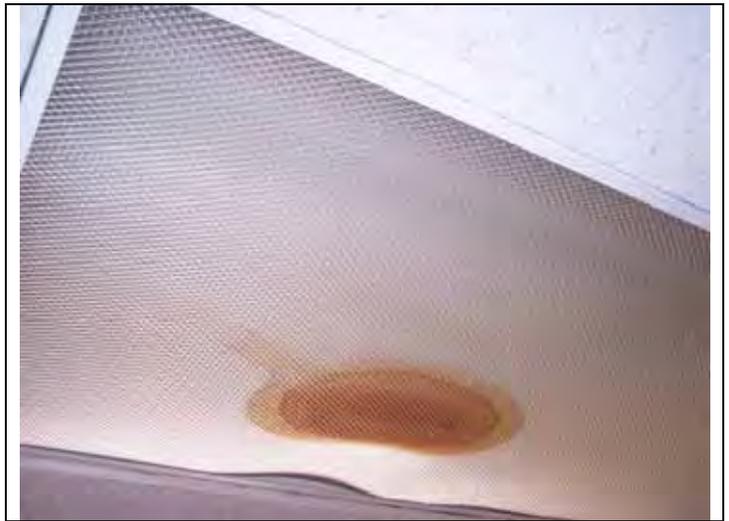
25. View of the service waiting area on the 1st floor of the building..

26. View of water staining within the ceiling light fixture in the conference room on the 2nd floor of the building.

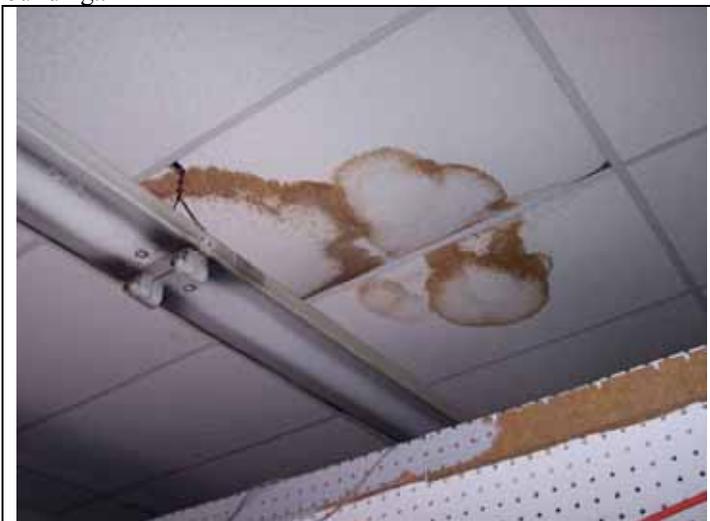
27. View of water staining on the ceiling tiles within the parts department on the 1st floor of the building.

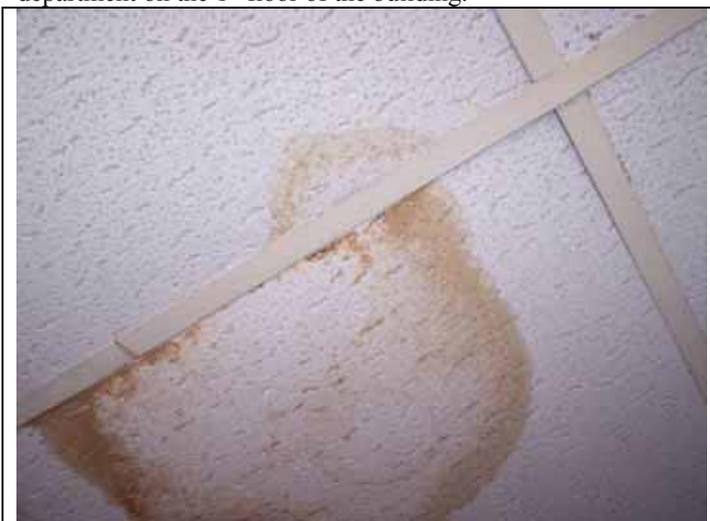
107. View of water staining on the ceiling within the office area.

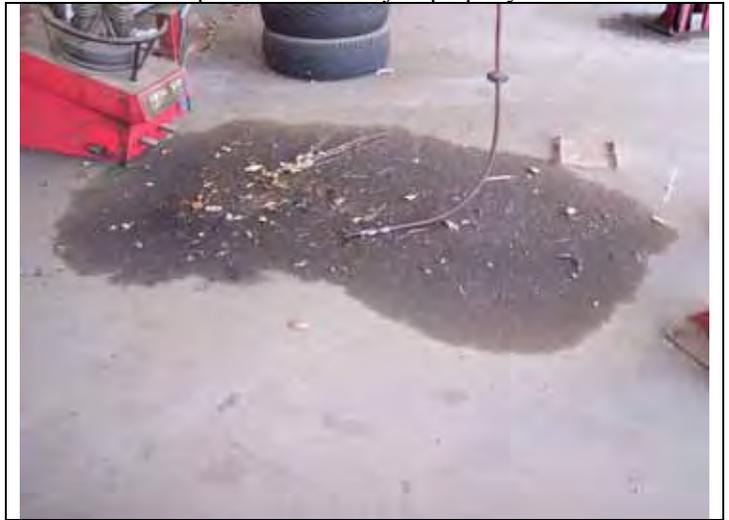
39. View of aboveground lifts within the service bays on the northeastern portion of the subject property.

40. View of surficial oil staining adjacent to the lifts within the service bays on the northeastern portion of the subject property.

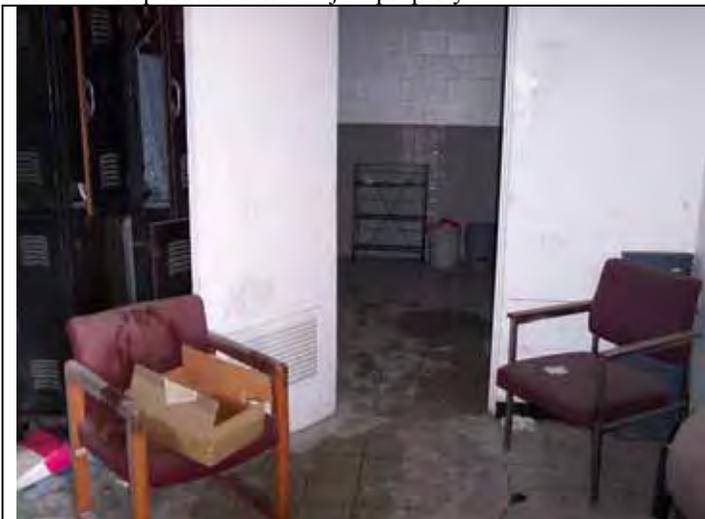
41. View of surficial oily staining located in the service locker room area adjacent to the service bays on the northeastern portion of the subject property.

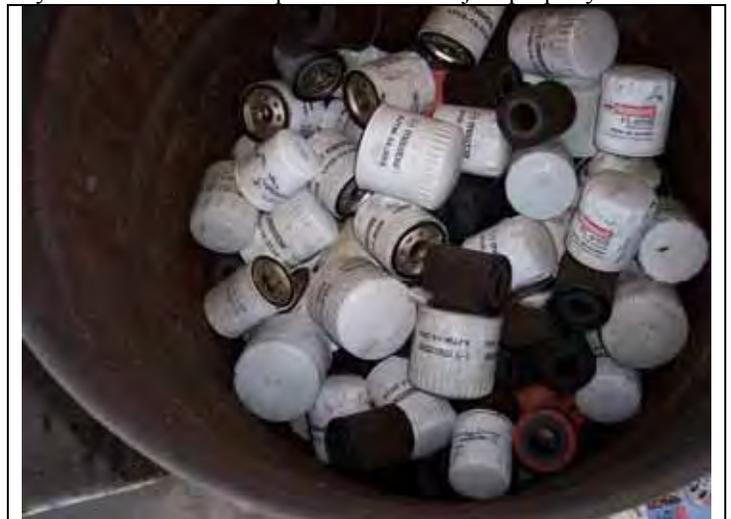
45. View of the 55-gallon drum filled with used oil filters and the waste oil AST within the service bays on the northeastern portion of the subject property.

46. View of the 55-gallon drum filled with used oil filters within the service bays on the northeastern portion of the subject property.

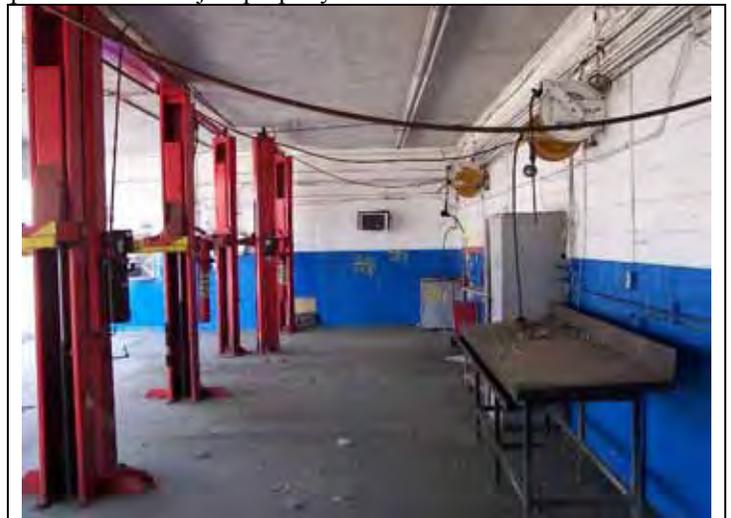
- The subject property is currently equipped with 23 aboveground hydraulic lifts and no active in-ground hydraulic lifts. No evidence of stains or leakage from the current units was observed. Partner observed two decommissioned in-ground fore and aft lifts and evidence of removed lifts during the site visit. Building permits reviewed at the West Covina Building Department identified that 10 hydraulic lifts were removed from the property in 1997. Ms.

71. View of the AST within the service bay area on the central portion of the subject property.

72. View of the service bays with lifts on the central portion of the subject property looking southeast, two decommissioned in-ground lifts were located in the two farthest bays.

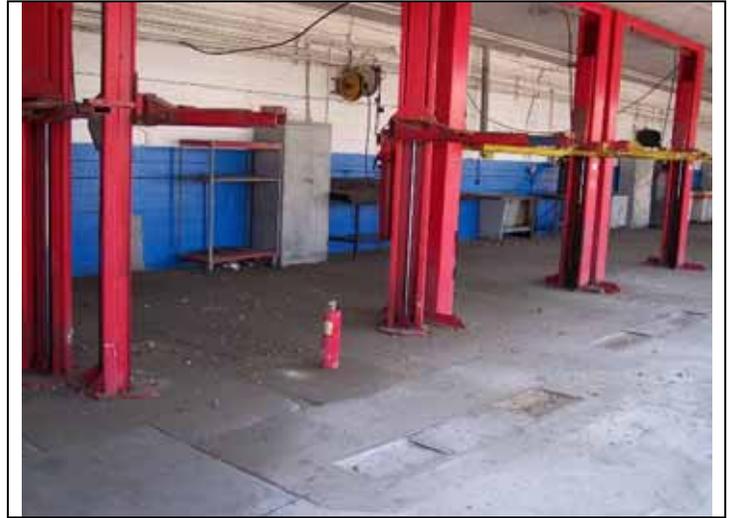
73. View of the waste oil AST and 55-gallon drums filled with used oil and used oil filters within the service bay area on the central portion of the subject property.

74. View of the service bays with lifts on the central portion of the subject property, and two decommissioned lifts..

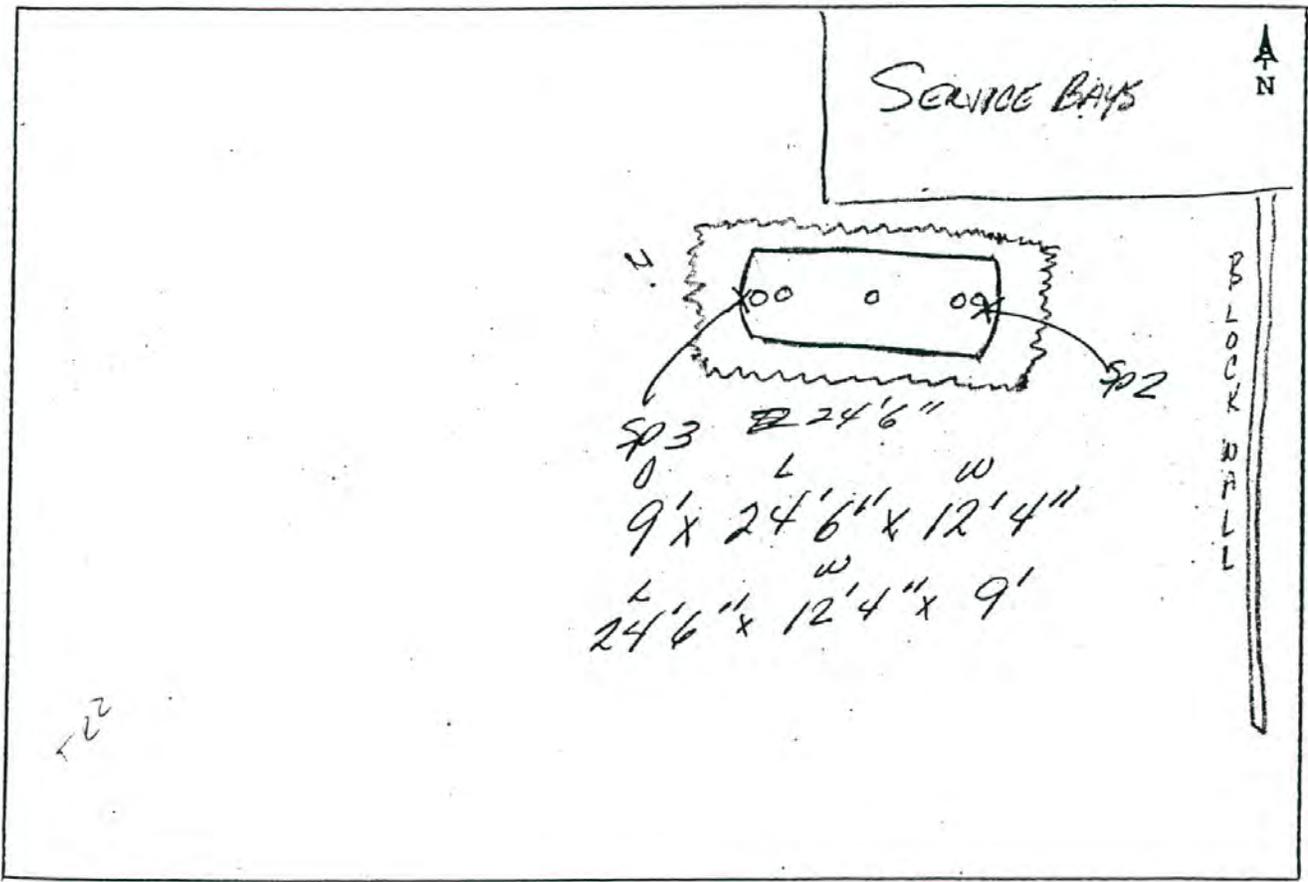
Show former tank and piping locations and fill pipe position. Show where samples were taken from: number samples and include depth (e.g., S-1-12' or S-E-12').

Remarks 4000 GALLON UNLEADED GAS TANK
SAMPLES TAKEN 2' Below TANK INJECT
 Report Prepared By Jim Galbraith

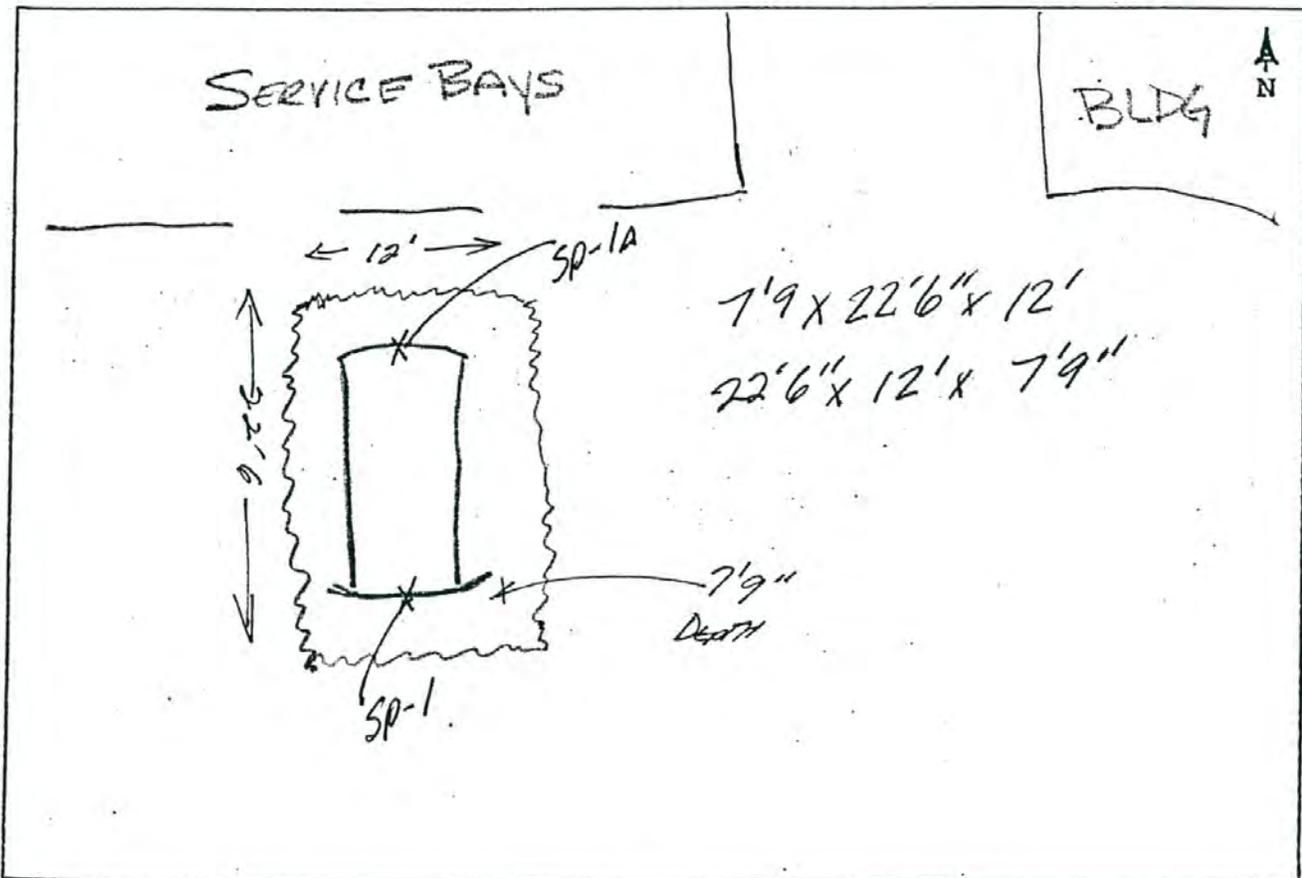
Show former tank and piping locations and fill pipe position. Show where samples were taken from: number samples and include depth (e.g., S-1-12' or S-E-12').

Remarks WAS A 550 gal. w/h TANK GROWN TO 1000 GALLONS w/h
UL # F485666 - DATE 67 - SAMPLES TAKEN 2' BELOW TANK INVERT
 Report Prepared By Jim Sult
